Society Members Bulletin

100th Anniversary of the sinking of RMS Titanic

THE LOSS OF THE TITANIC - AN ENGINEER'S VIEWPOINT

By Lieutenant Commander Geoffrey Carr MSc CEng MIMechE Royal Navy (Retired)

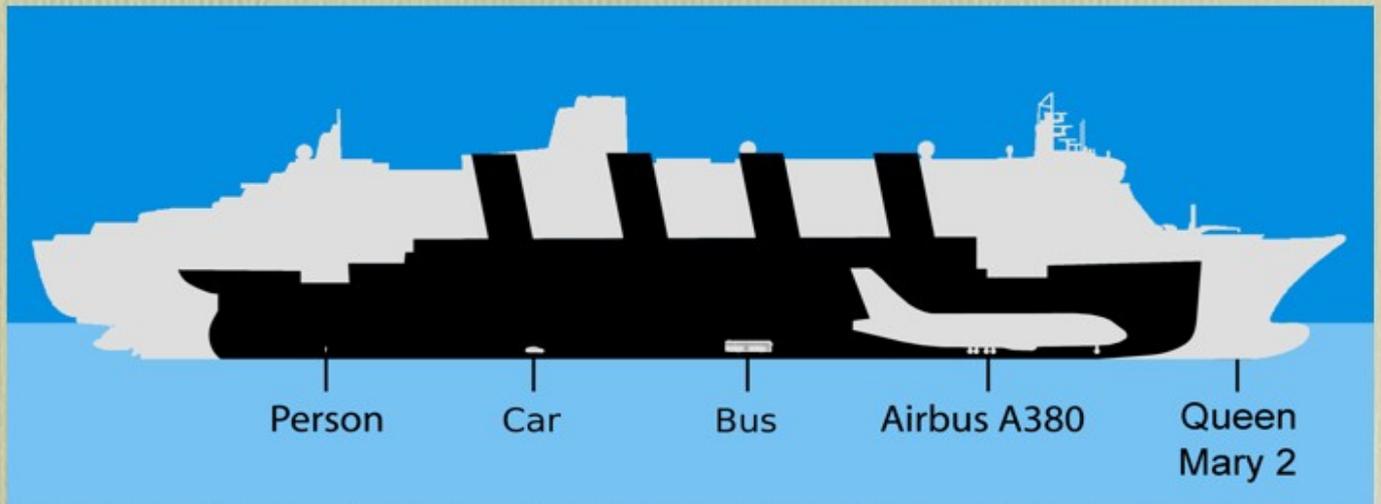
Figure 2

TITANIC herself was 269m (882' 6") long with a beam of 28m (92' 6") and a gross tonnage of 46,328 tons. Even by today's standards she was big. ('Figure 2')

TITANIC VERSUS MODERN TRANSPORT

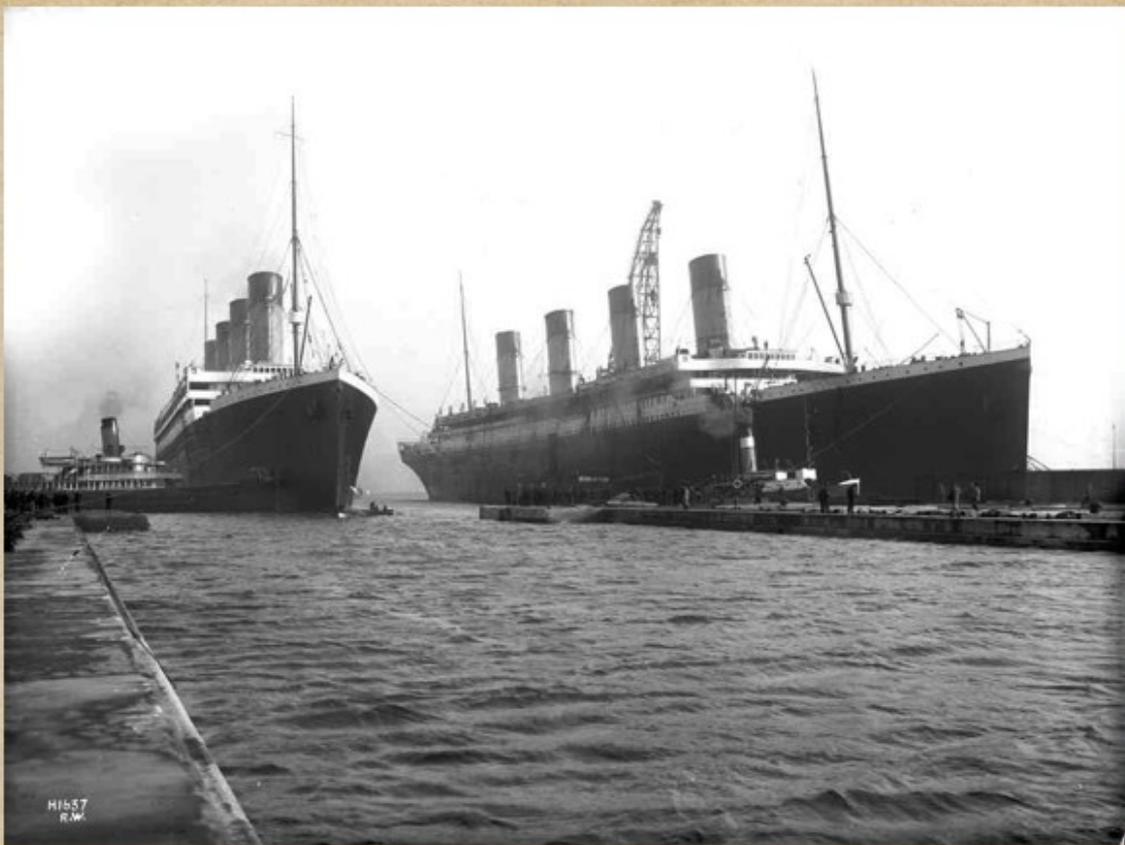
Figure 3

OLYMPIC AND TITANIC WERE SISTER SHIPS

the largest ship of her kind; her sister ship OLYMPIC was a year ahead of her and was virtually identical ('Figure 3').

OLYMPIC only had a slightly smaller gross tonnage because part of her promenade deck was not glassed in like it was on the TITANIC. That gave her a slightly smaller enclosed volume and, hence, smaller Gross Tonnage. The significant point is that OLYMPIC had already completed voyages across the Atlantic when TITANIC sailed on her maiden voyage. If TITANIC had not sunk on her maiden voyage she would not have been regarded, historically, as particularly remarkable - though that it should be made clear that *both* ships were the biggest and most magnificent of their kind in terms of size, luxury and innovation.

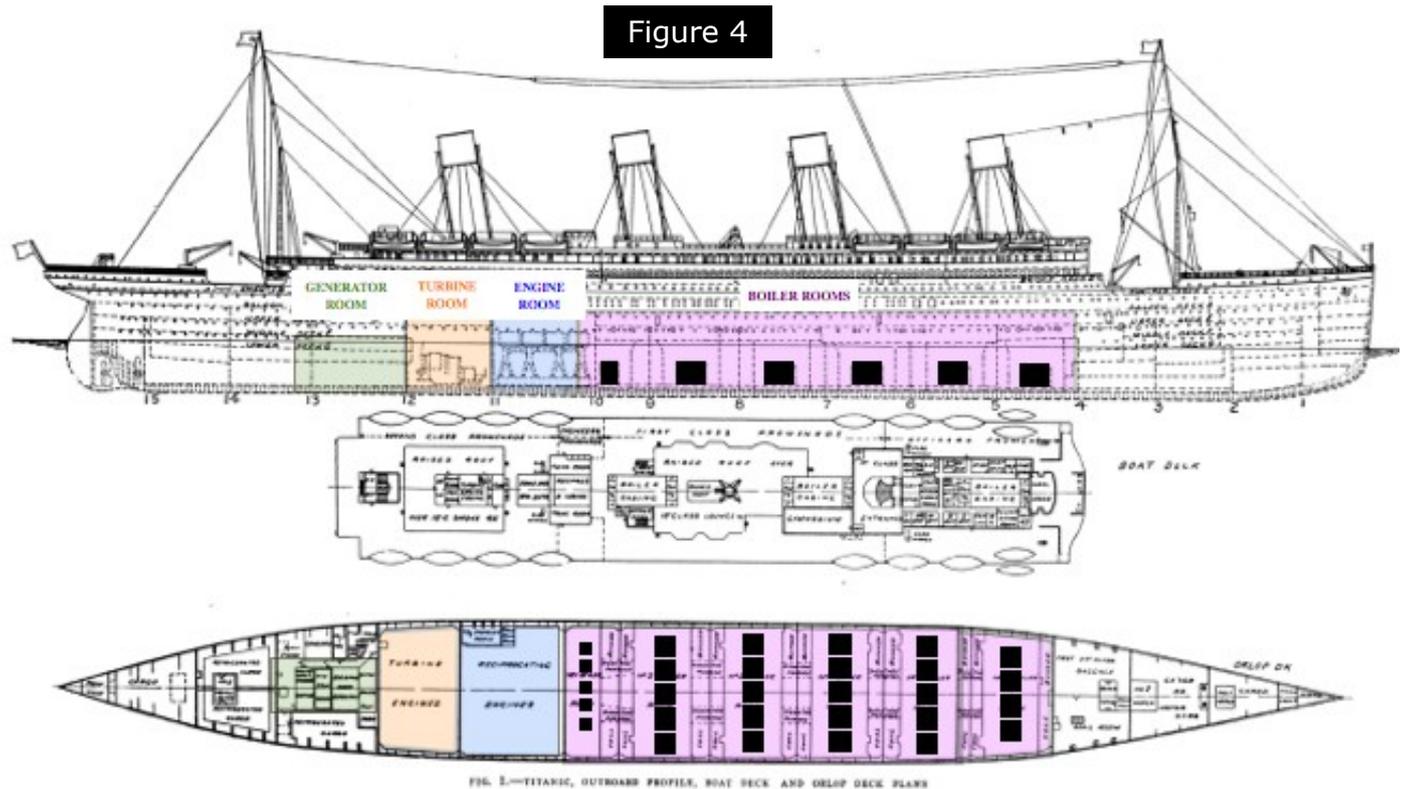
The machinery of these ships matched their size, and the machinery spaces took up a significant proportion of TITANIC's length, as was common in fast steam ships ('Figure 4').

There were six boiler rooms (shown in purple) with 29 coal-fired boilers in all - mostly arranged five-abreast in each. Aft of that was the engine room (in blue), then the turbine room (in yellow), and finally the main generator room (in green). The boilers were coal-fired and of the fire-tube type. Twenty four were double-ended, with six furnaces each, hand-stoked by two stokers. The remainder were single-ended and intended for use when the ship was steaming auxiliary. They burned 650 tons of coal a day at cruising speed, generating saturated steam at 14.8 bar (215 lbf/in²).

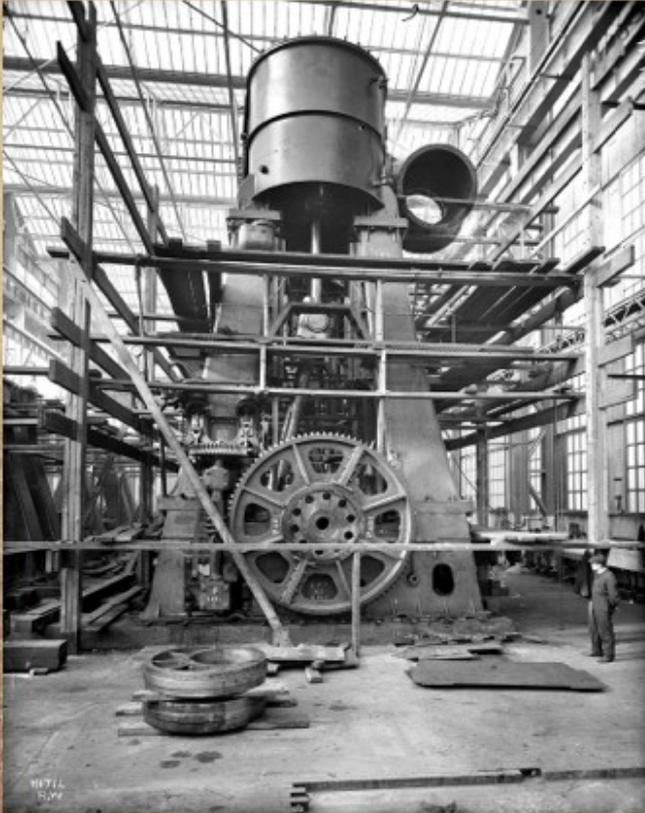
Figure 5

Each wing shaft was driven by a triple expansion, 4-cylinder, double-acting reciprocating engine ('Figure 5'). These behemoths stood 10m (30 feet) high and the crank stroke, alone, was 2m (6ft 3"). The largest cylinder - the LP cylinder - had a diameter of 2.5m (8ft 1"). Each of these units developed 11.2 MW (15,000 shp) at 75 rpm - less than half of the power of a WR21 gas turbine used today in the latest RN warships; but they were reliable, economical, quiet and state-of-the-art in their day. There was no need for a gearbox, because that type of engine develops enormous torque from rest. The centre-line shaft was

TITANIC MAIN RECIPROCATING ENGINES

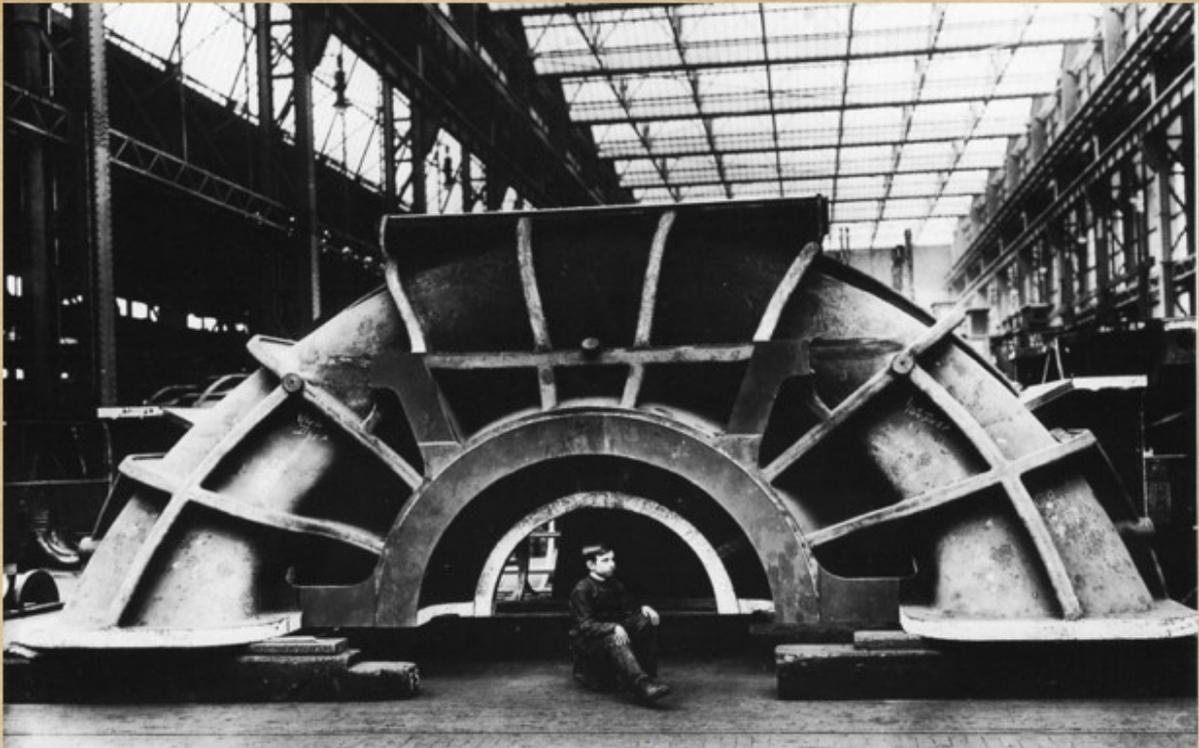
Figure 6

TITANIC CENTRE-LINE SHAFT TURBINE CASING

The enormous size was dictated by the fact that it operated with exhaust steam at very low pressure and, hence, high volume of steam. Pressure at entry was 0.6 bar absolute (9 lbf/in²) and the shaft ran at 165 rpm - over twice the speed of the wing shafts. Again, there was no gearbox on that shaft.

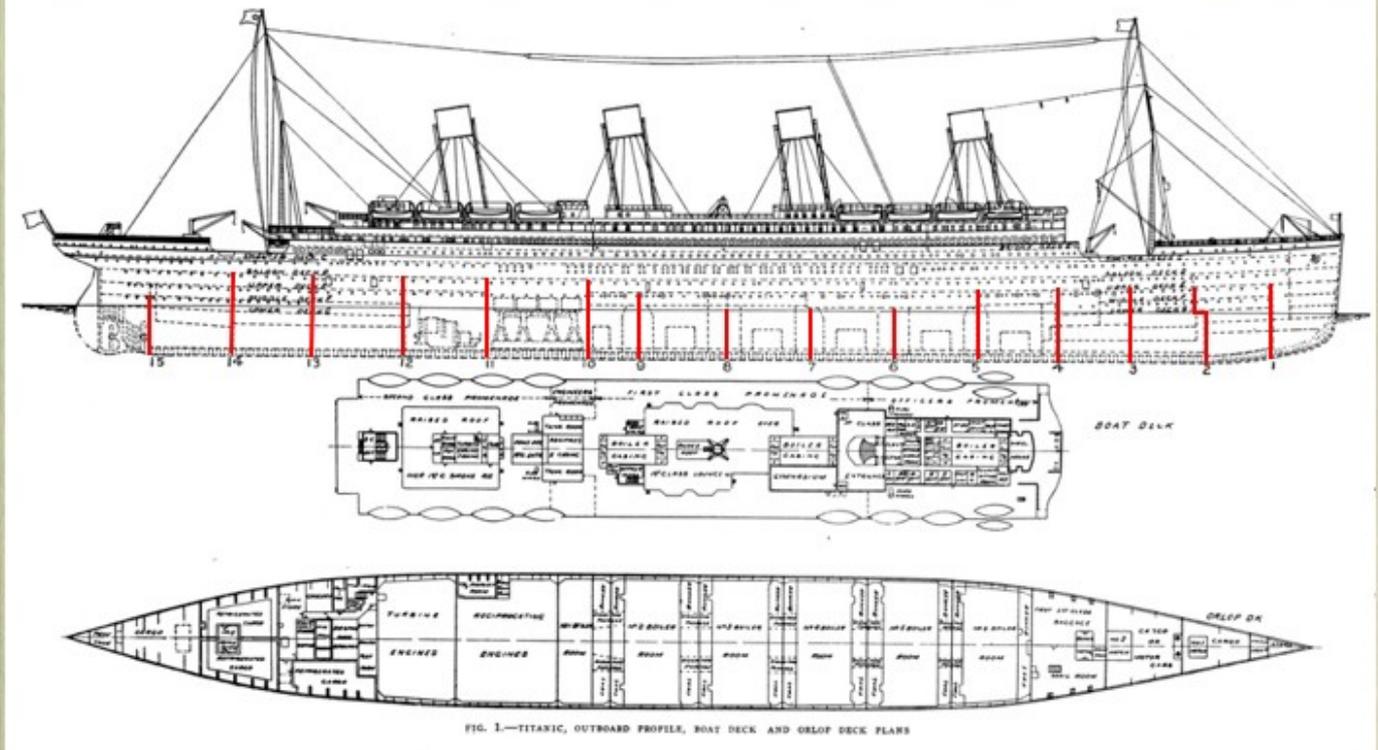
Figure 7

She was equipped with 15 watertight bulkheads ('Figure 7'), some with hydraulic self-closing watertight doors. This was not a new innovation, but it was not mandatory at the time. There was a full-length double bottom that extended at least 1.6m (5ft 3") above the keel.

RMS TITANIC – WATERTIGHT BULKHEADS

She could endure flooding in four of the forward compartments and still stay afloat; the regulations required staying afloat only with two compartments flooded – and still do.

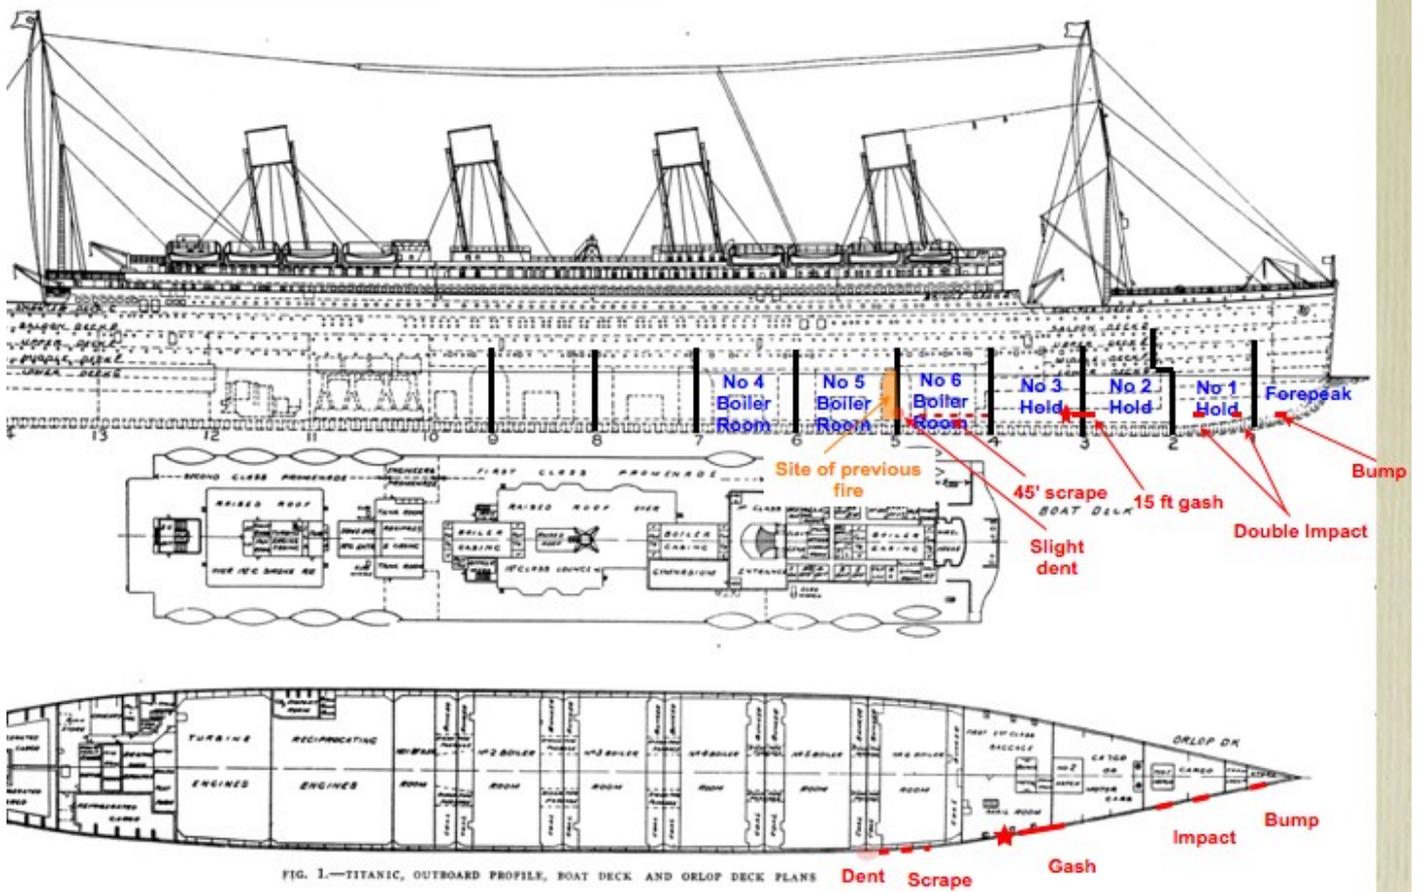
Figure 9

The iceberg scraped down the starboard side, buckling the underwater hull and popping rivets 7m (24 ft) below the water line and 3m (10 ft) above the keel ('Figure 9'). There was not a 100m (300 foot) gash down the side as was first believed: the damage was sporadic and varied; but it did extend over a large length and was later calculated to be the equivalent size of a hole over 1 m² (12 feet²) in area. Water immediately began to pour into the first six compartments and, from that moment, she was doomed.

DAMAGE IN 10 SECONDS

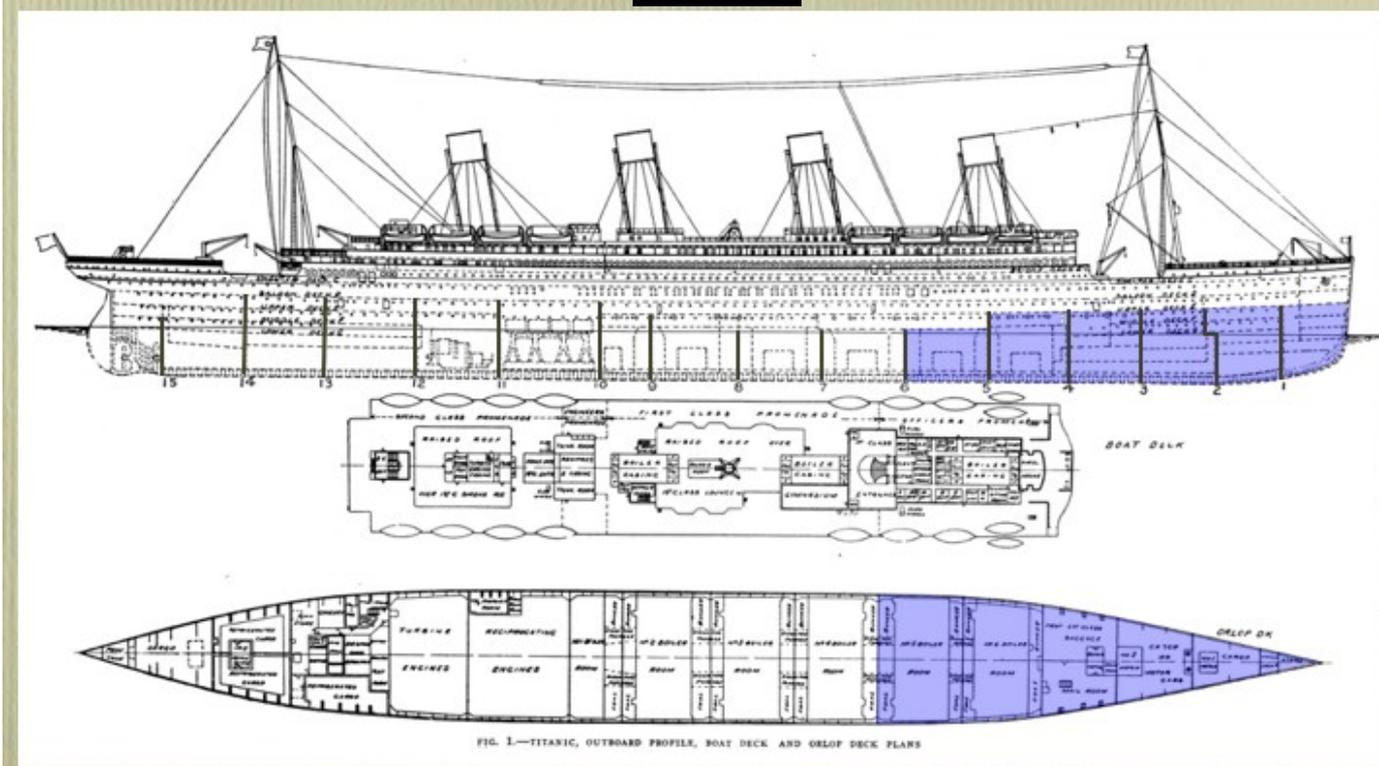
Figure 10

It will be recalled that TITANIC had 15 watertight bulkheads that extended right up to various deck-levels. Beyond that, the decks were not watertight. In a warship, decks and bulkheads are watertight at all levels because one expects warships to be able to survive a lot of punishment. However, that sort of watertightness is difficult to achieve in practical terms in a passenger ship, where people expect to be able to move around as in every-day life, without stepping over storm sills or opening heavy hatches. In TITANIC, because the watertight bulkheads only reached as far as certain deck levels, water poured over the top of the for'd bulkheads into the next compartment, then the next one, as the ship sank lower and lower into the water. This was not a design flaw, however; it was an accepted part of the design. With three of her forward compartments flooded, the water would not have flooded over the top of the bulkheads; even with four compartments flooded, and the water pouring over the top of some bulkheads, she would have stayed afloat. But she could not cope with five or more compartments open to the sea ('Figure 10' - next page).

RMS TITANIC – EXTENT OF FLOODING

Overall, flooding was slow at first and the severe damage was confined to just Number 3 hold, just under the foremast. However, it was steady and, within the first few minutes of assessing the damage, Thomas ANDREWS of Harland and Wolff, who was on-board, told Captain SMITH that the ship was going to sink and that they had about 2 hours. It says something for his ability in the days before computers or calculators that his calculation was correct. ANDREWS was not the naval architect who designed the ship, he was Managing Director of the Design Department and, sadly, he went down with the ship.

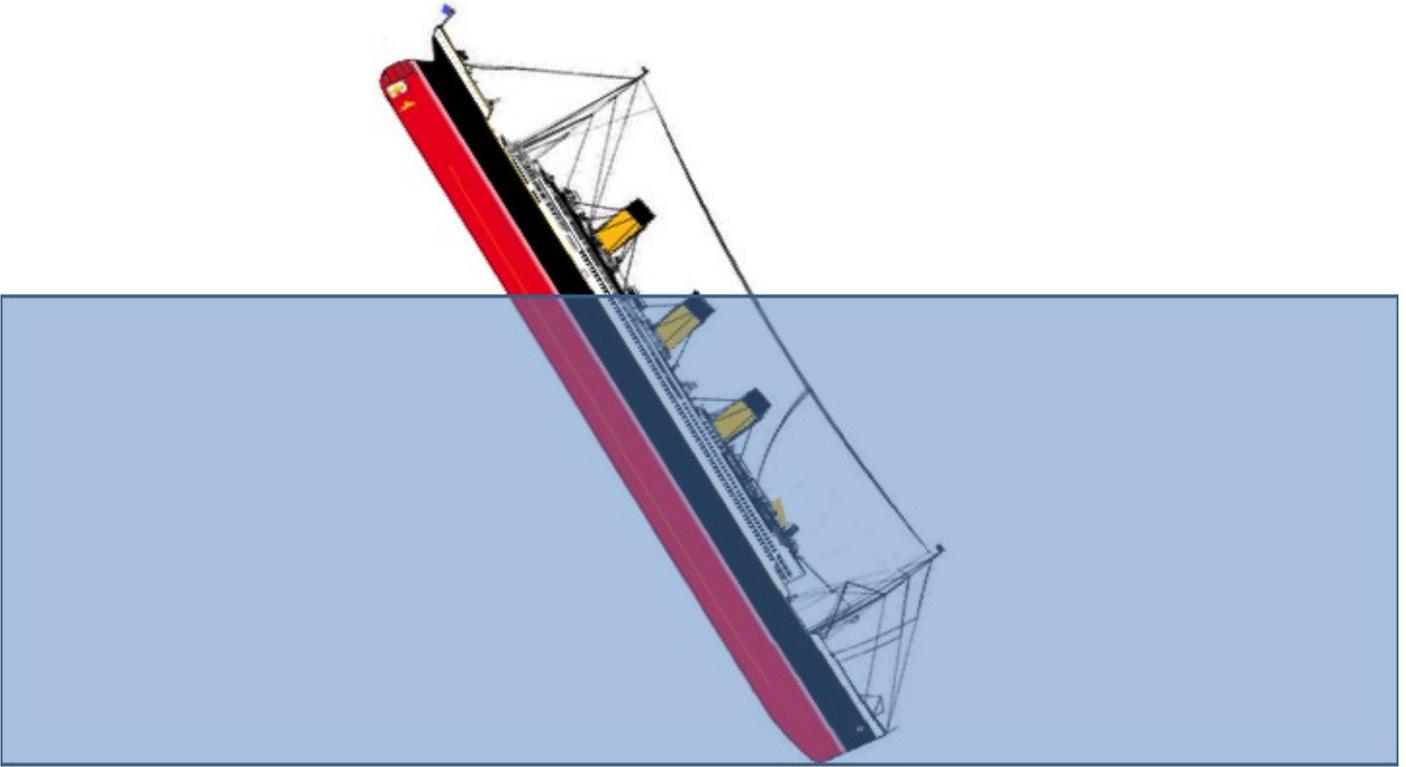
Ships sink either by capsizing or plunging by the head or the stern. TITANIC plunged by the head, with her stern sticking high out of the water before she went ('Figure 14' below).

TITANIC AT 0220 - ABOUT TO PLUNGE

The official enquiry concluded that she did *not* break in two, but the general view today, from examining the wreck, is that her hull did fracture near the fourth funnel under the enormous strain of sticking out of the water. The stern section lingered briefly because of its buoyancy, but then that went too. She finally sank at twenty past two on the morning of 15 April 1912.
